Church House, St John's House, St John's Road, Great Clacton, Essex.  
Historic Impact Justification Report on proposal to alter the interior layout of Flat 2a  
and Flat 2b on the first and second floors of Church House.

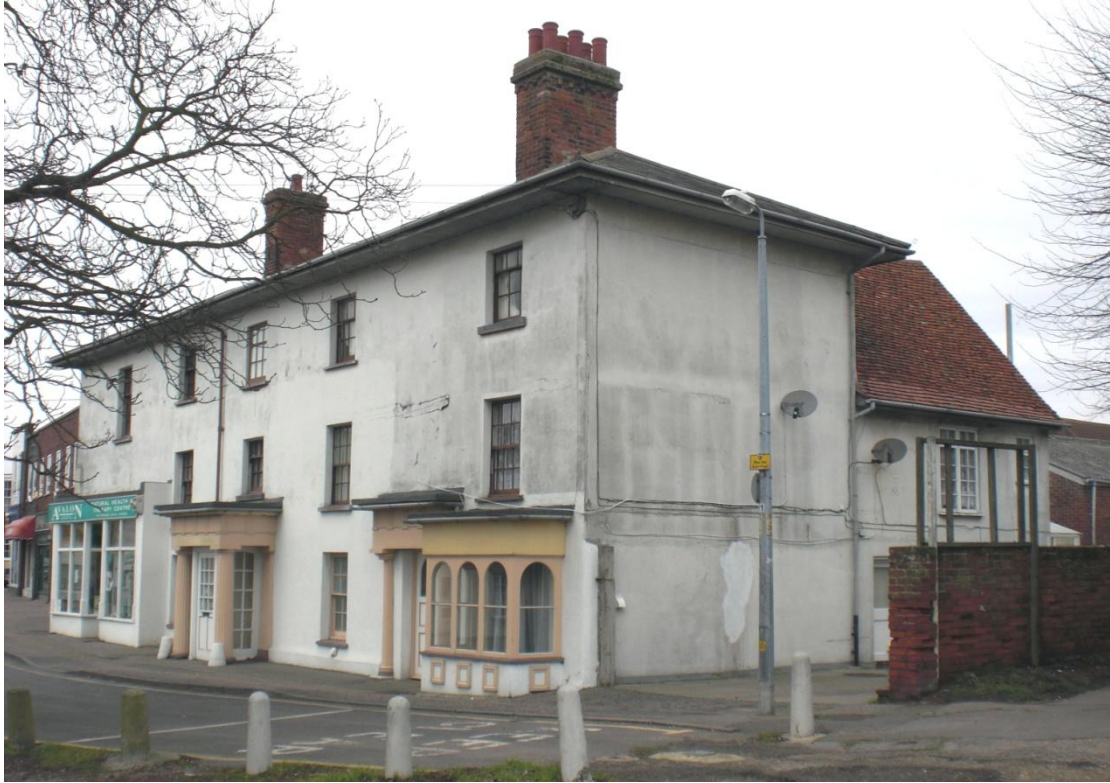
Church House from the SE. Flat 2a occupies the near bay and range on the two upper floors. Flat 2b occupies most of the rest of the two upper floors.

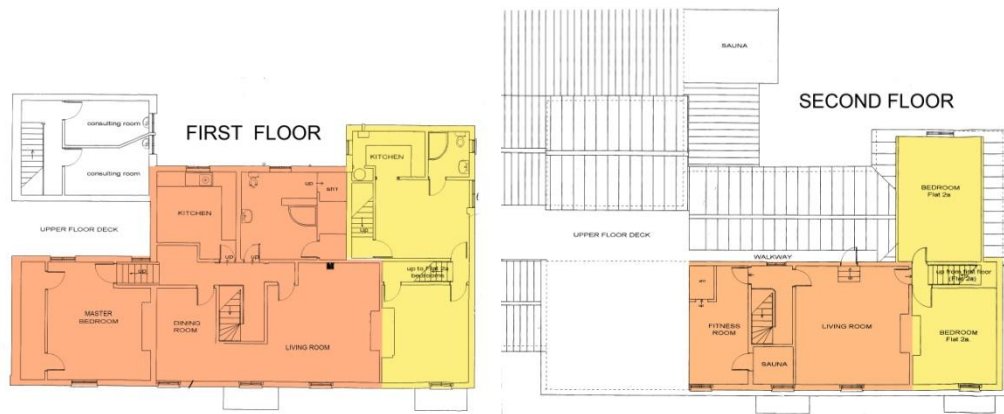
First and second floor plans showing the division of the property into Flats 2a and 2b.

Today the house is divided on the ground floor into three retail units while there are two flats above. Flat 2a occupies the end bay and eastern range on two floors while Flat 2b is much larger and occupies most of the rest of the house.
